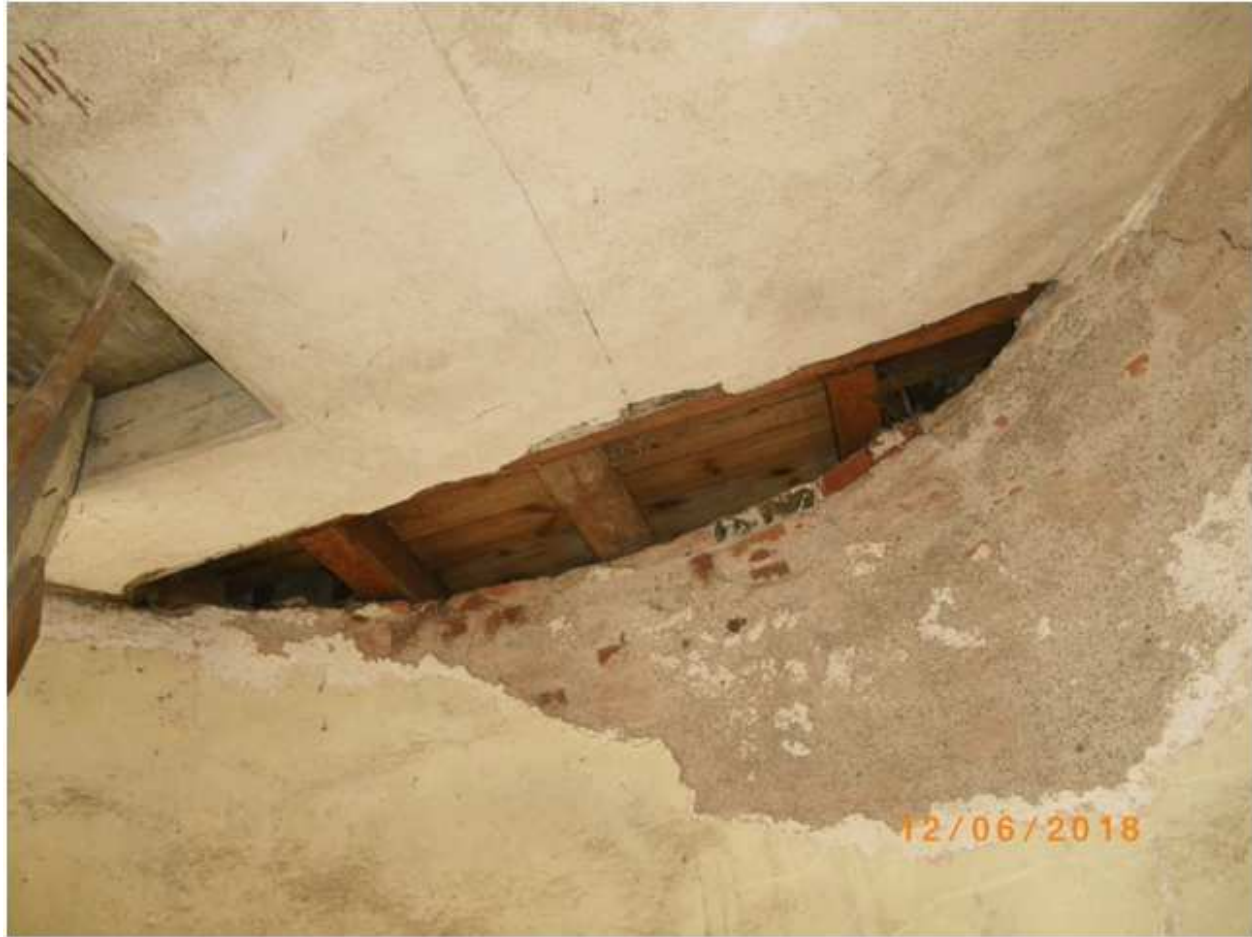
2: 2018\_02 sichtbare Holzkonstruktion zeigt keinerlei Schäden

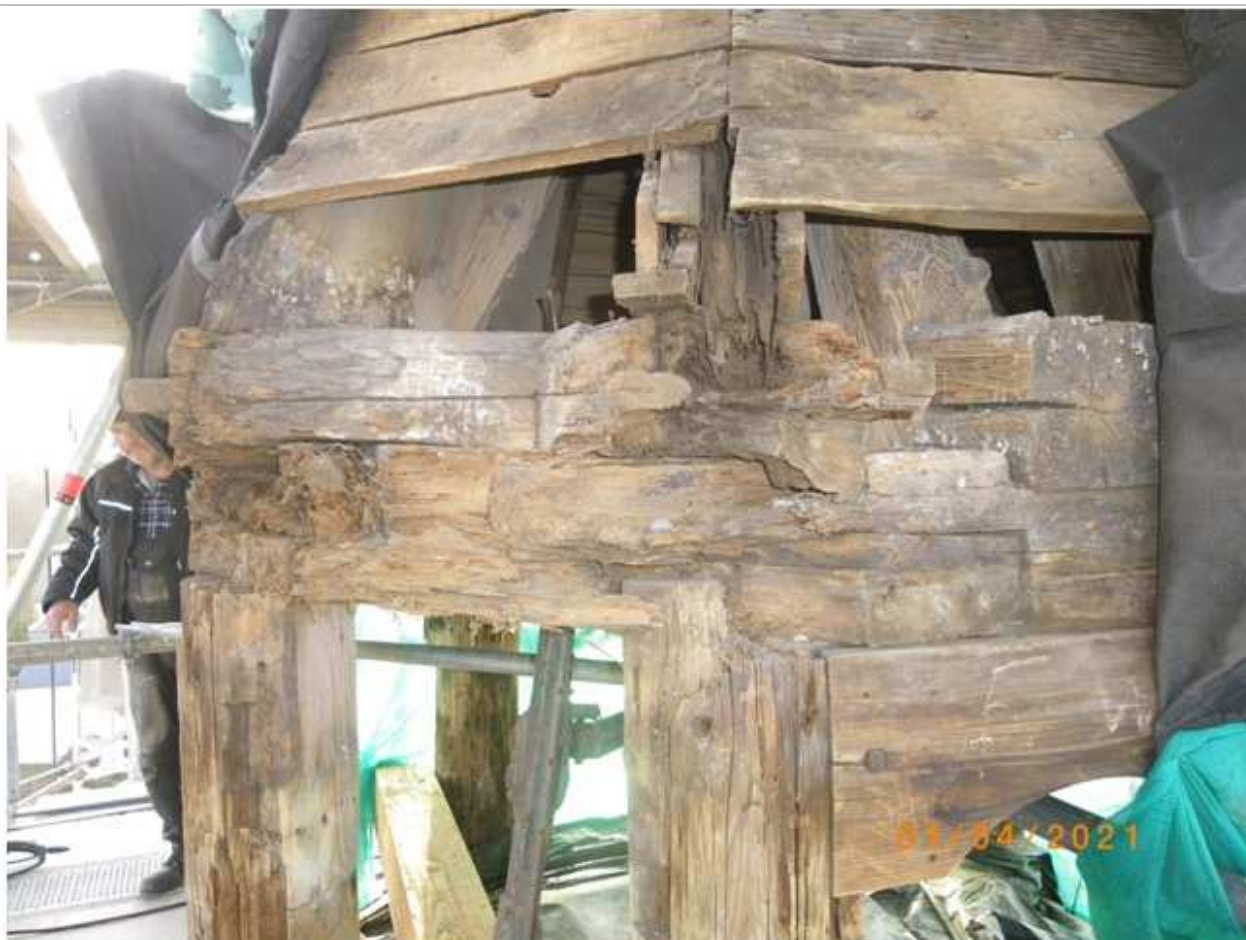
104: 20210401\_IMGP1323\_Haube Schäden
