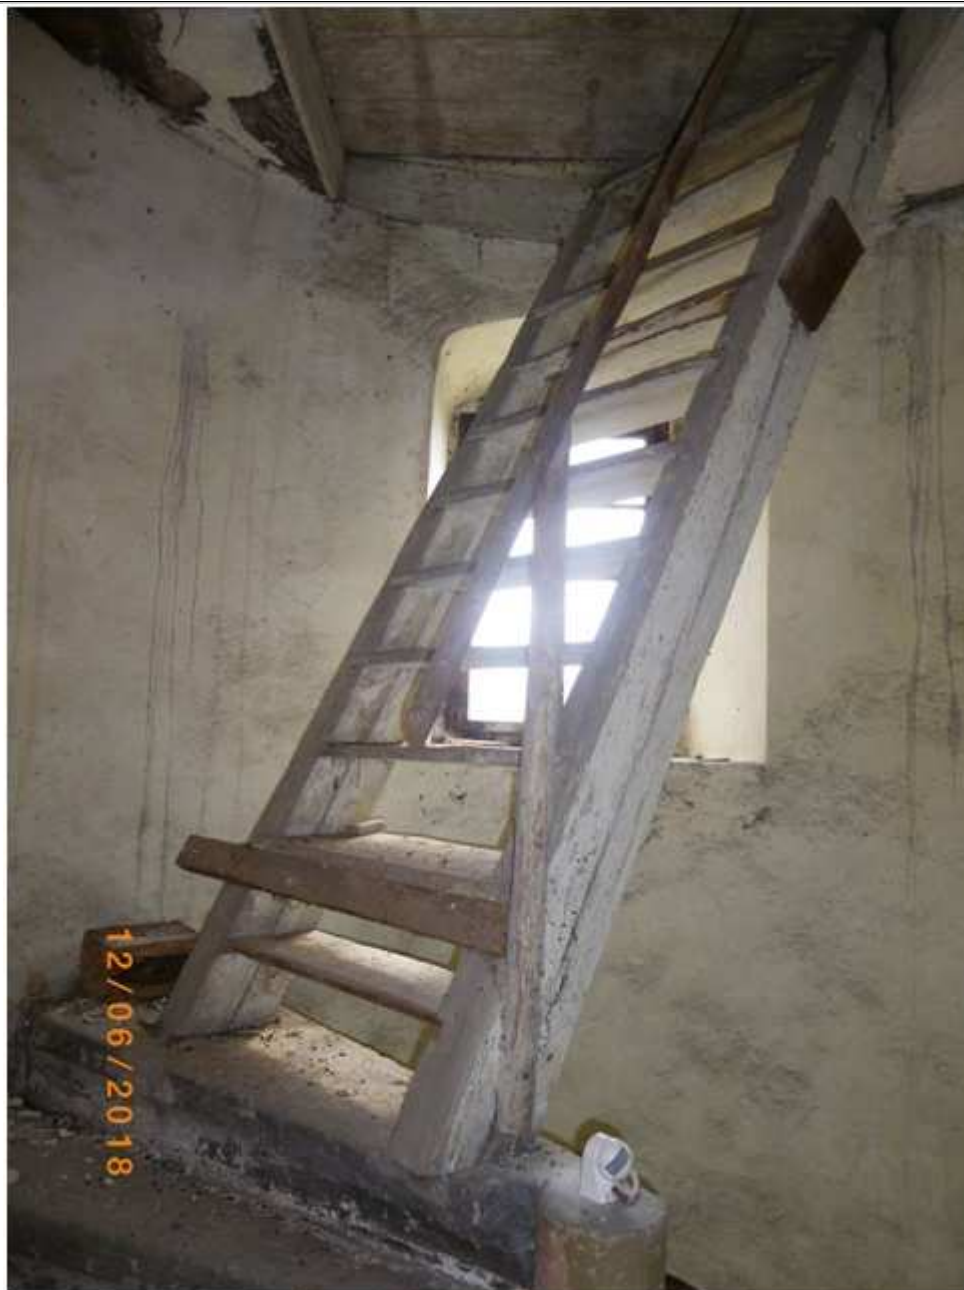
1: 2018\_01 Zugang zum Südturm

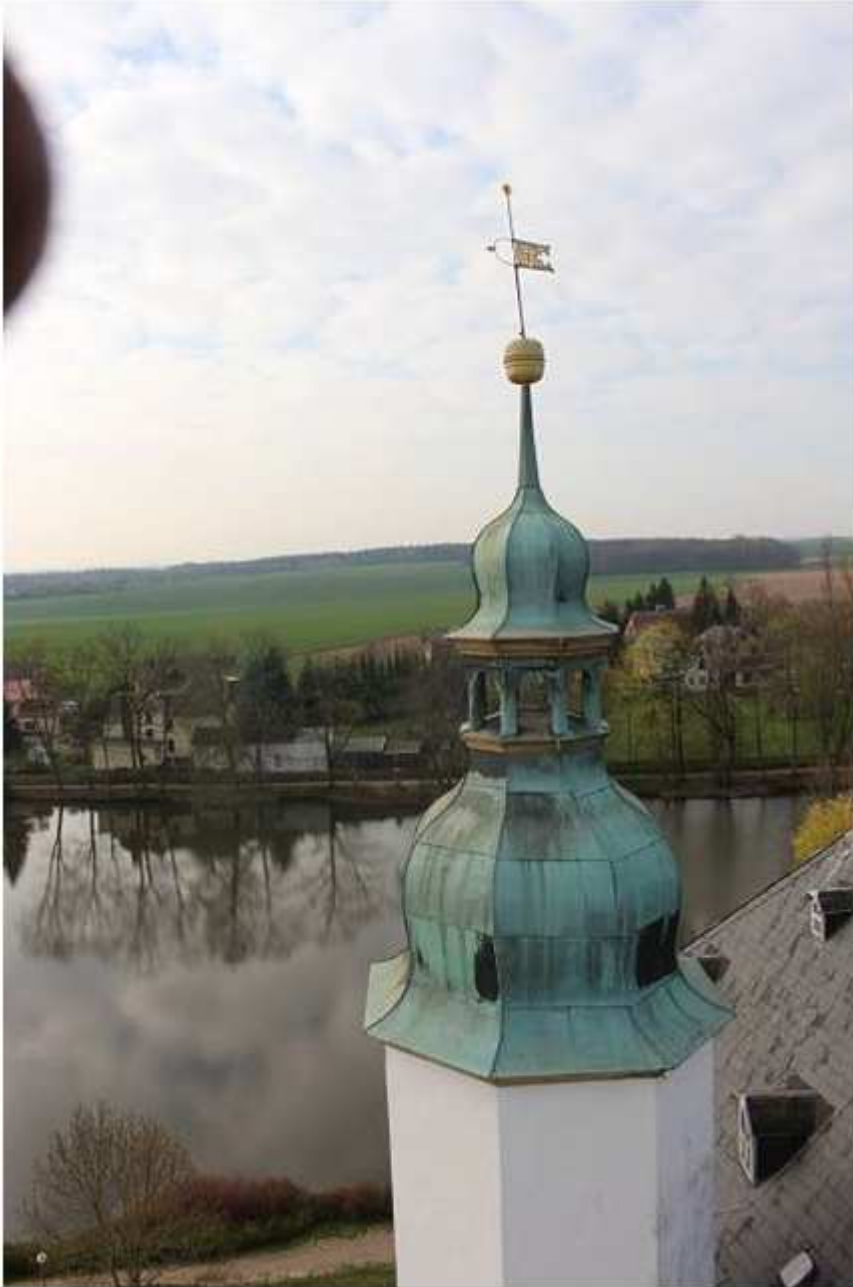
3: 2019\_01\_IMG\_2606\_Turmhaube Aufnahme mit Drohne

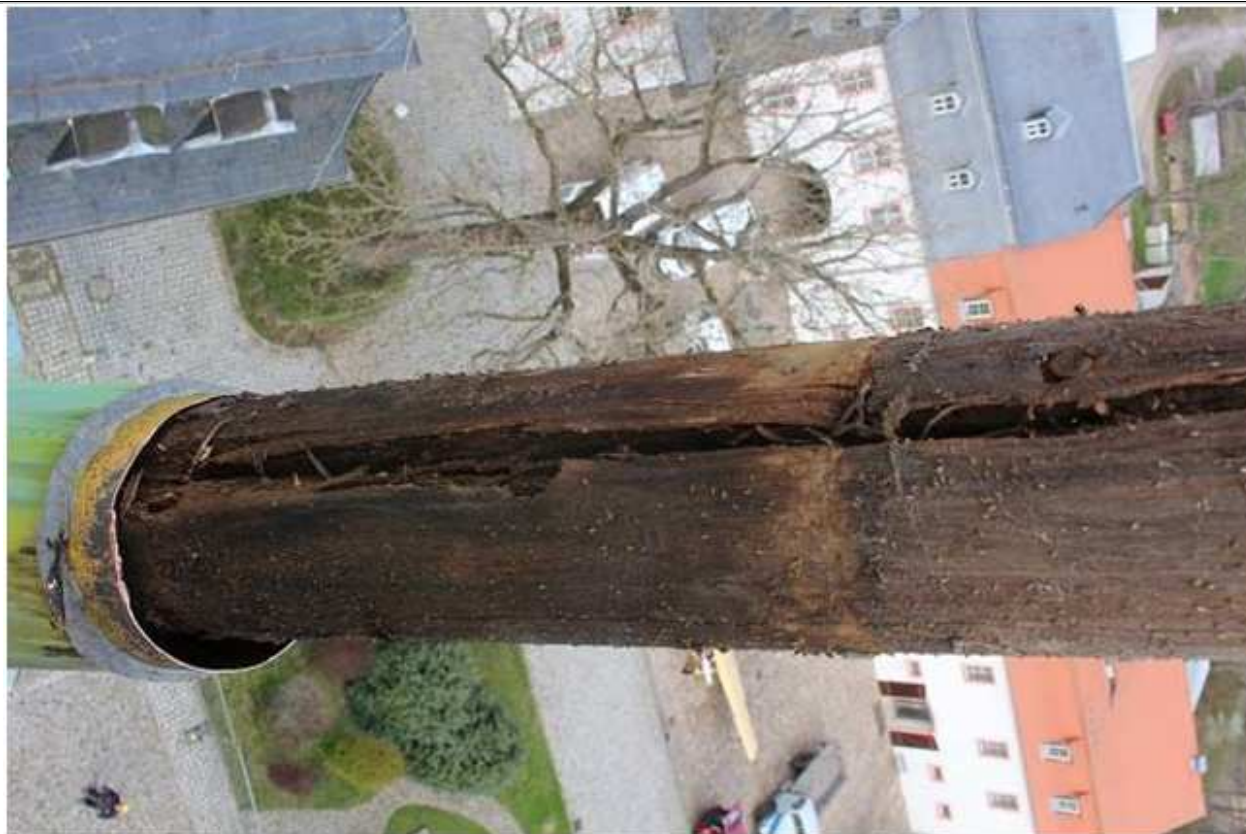
4: 2019\_02\_IMG\_2726\_Stiel Kugel

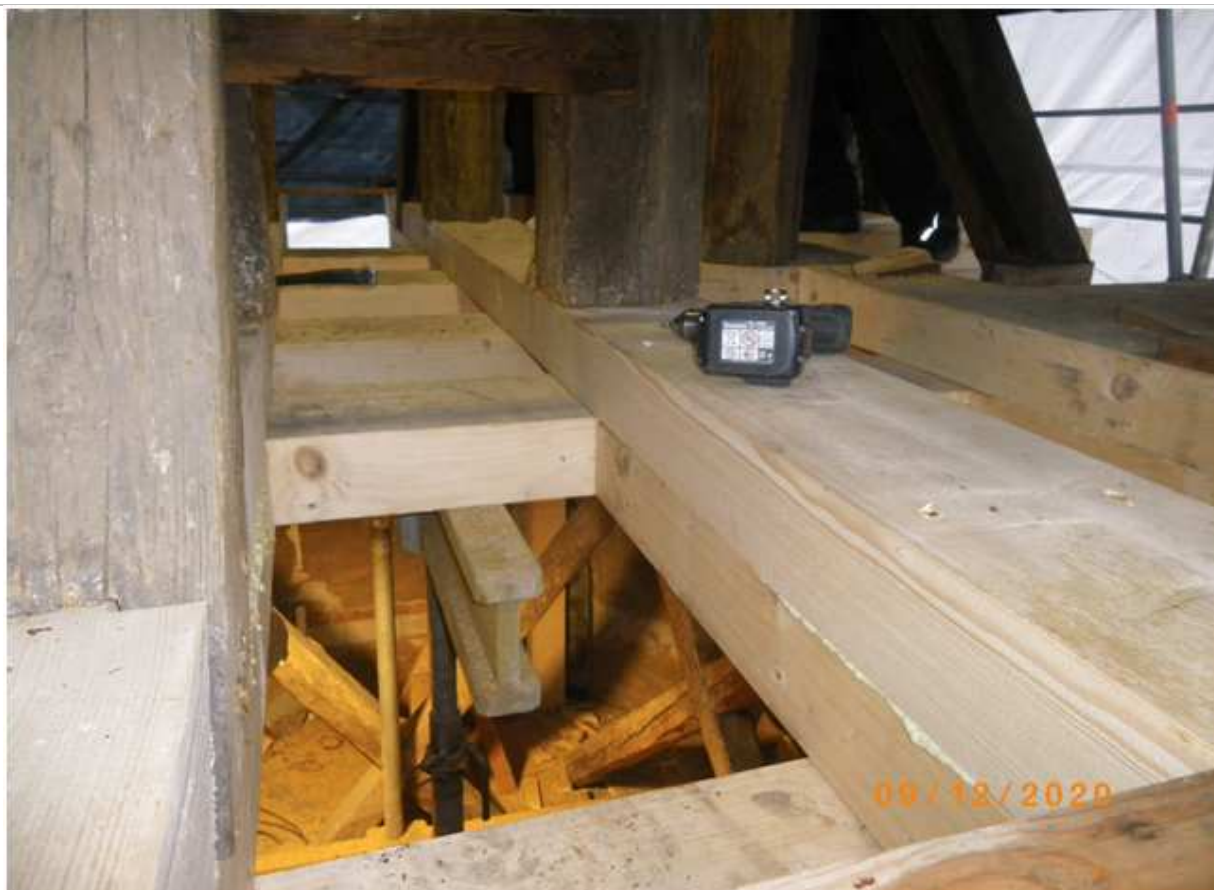
81: 20201106-IMGP0878\_Sparren Turmhaube

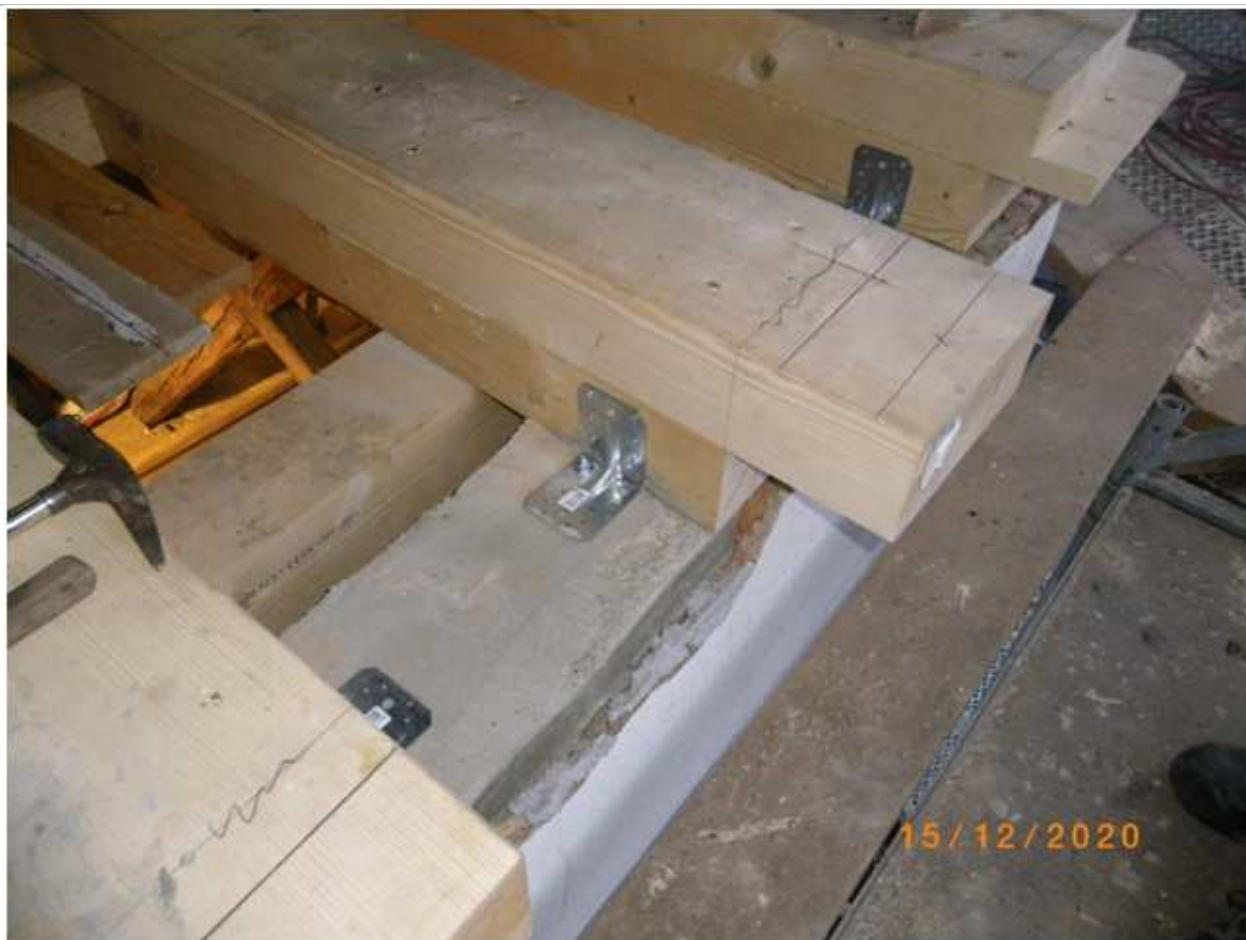
90: 20201209-IMGP0935\_Decke Turmhaube

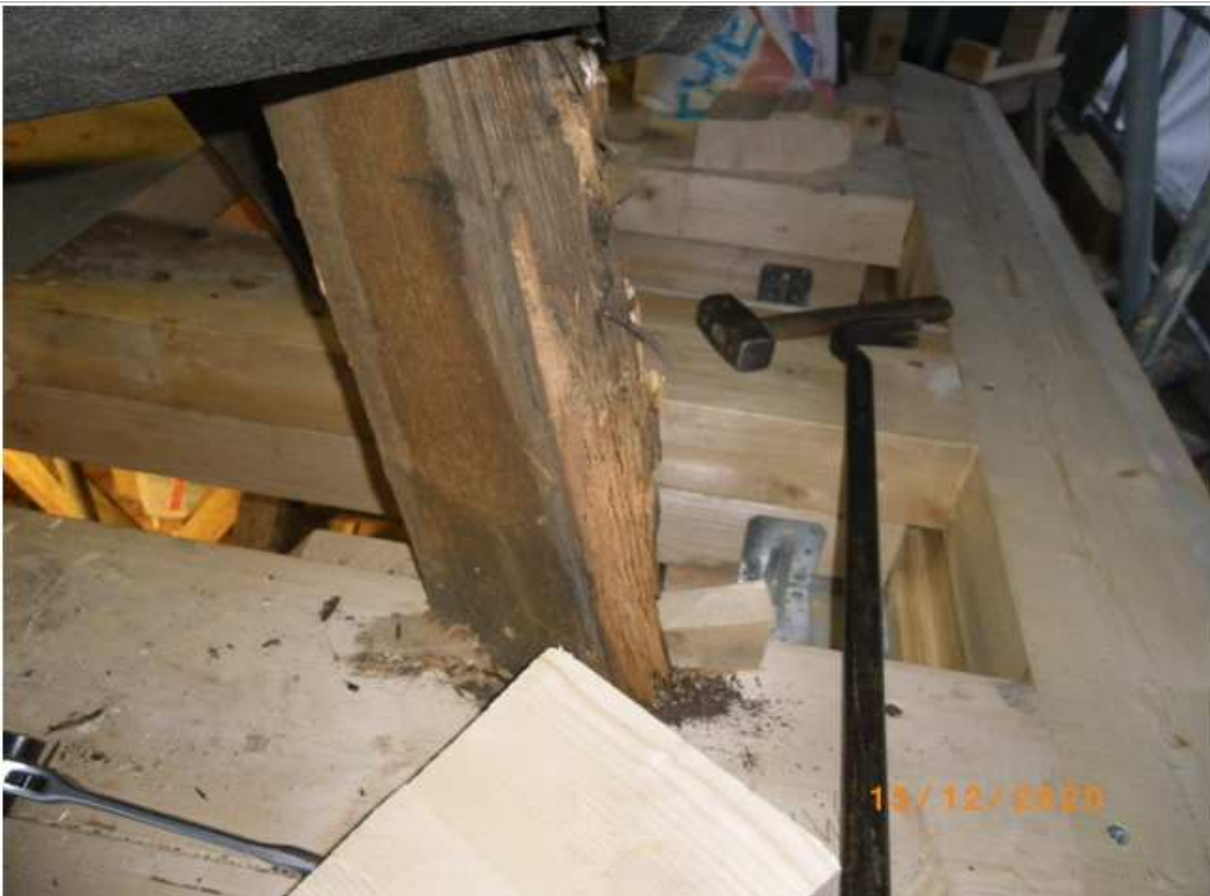
92: 20201215-IMGP0977\_Holzfraß Stütze

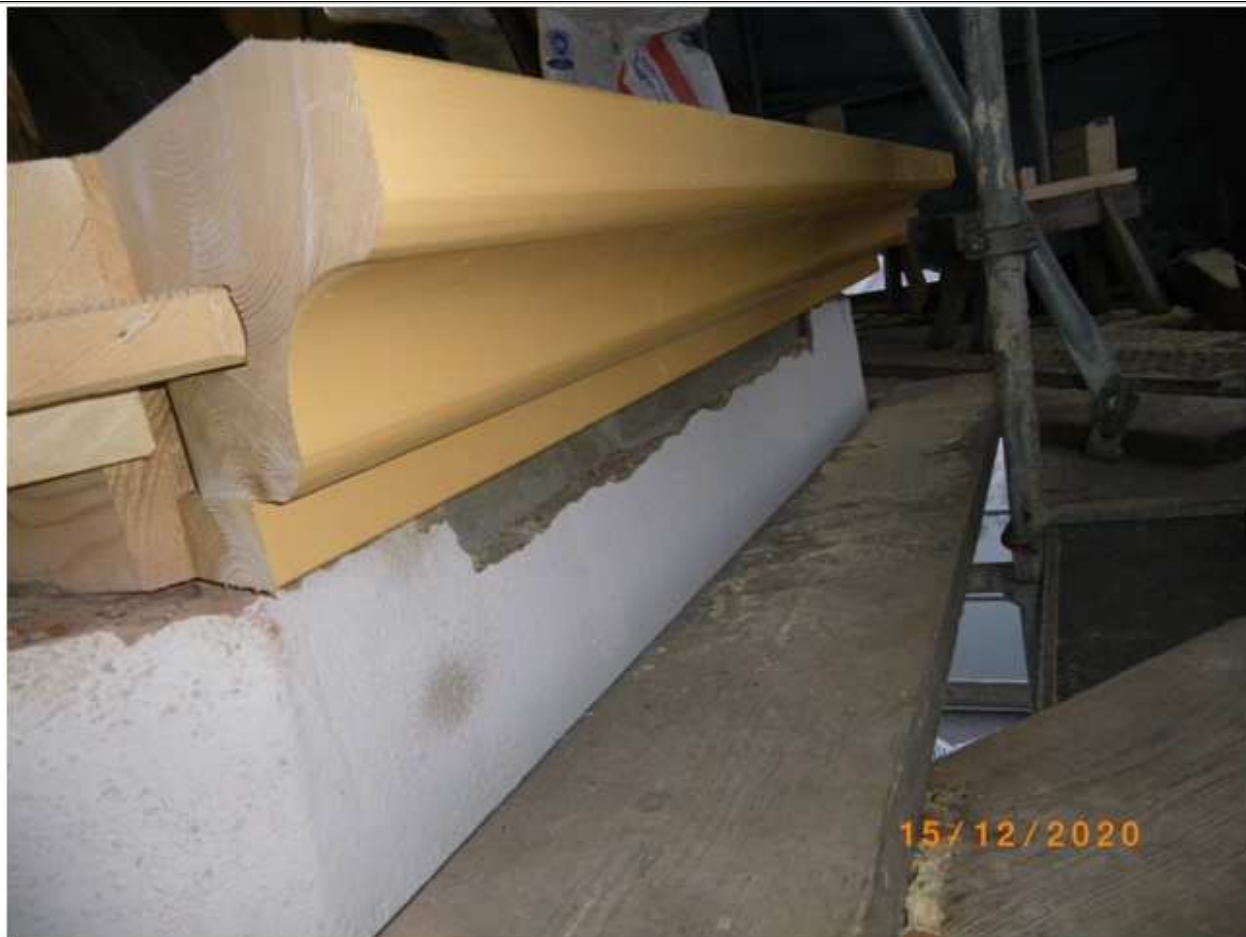
94: 20201215-IMG0979\_Holzgesims
